**FIFTH FIVE-YEAR REVIEW REPORT FOR
JOSEPH FOREST PRODUCTS SUPERFUND SITE
WALLOWA COUNTY, OREGON**

**U.S. Environmental Protection Agency
Region 10
Seattle, Washington**

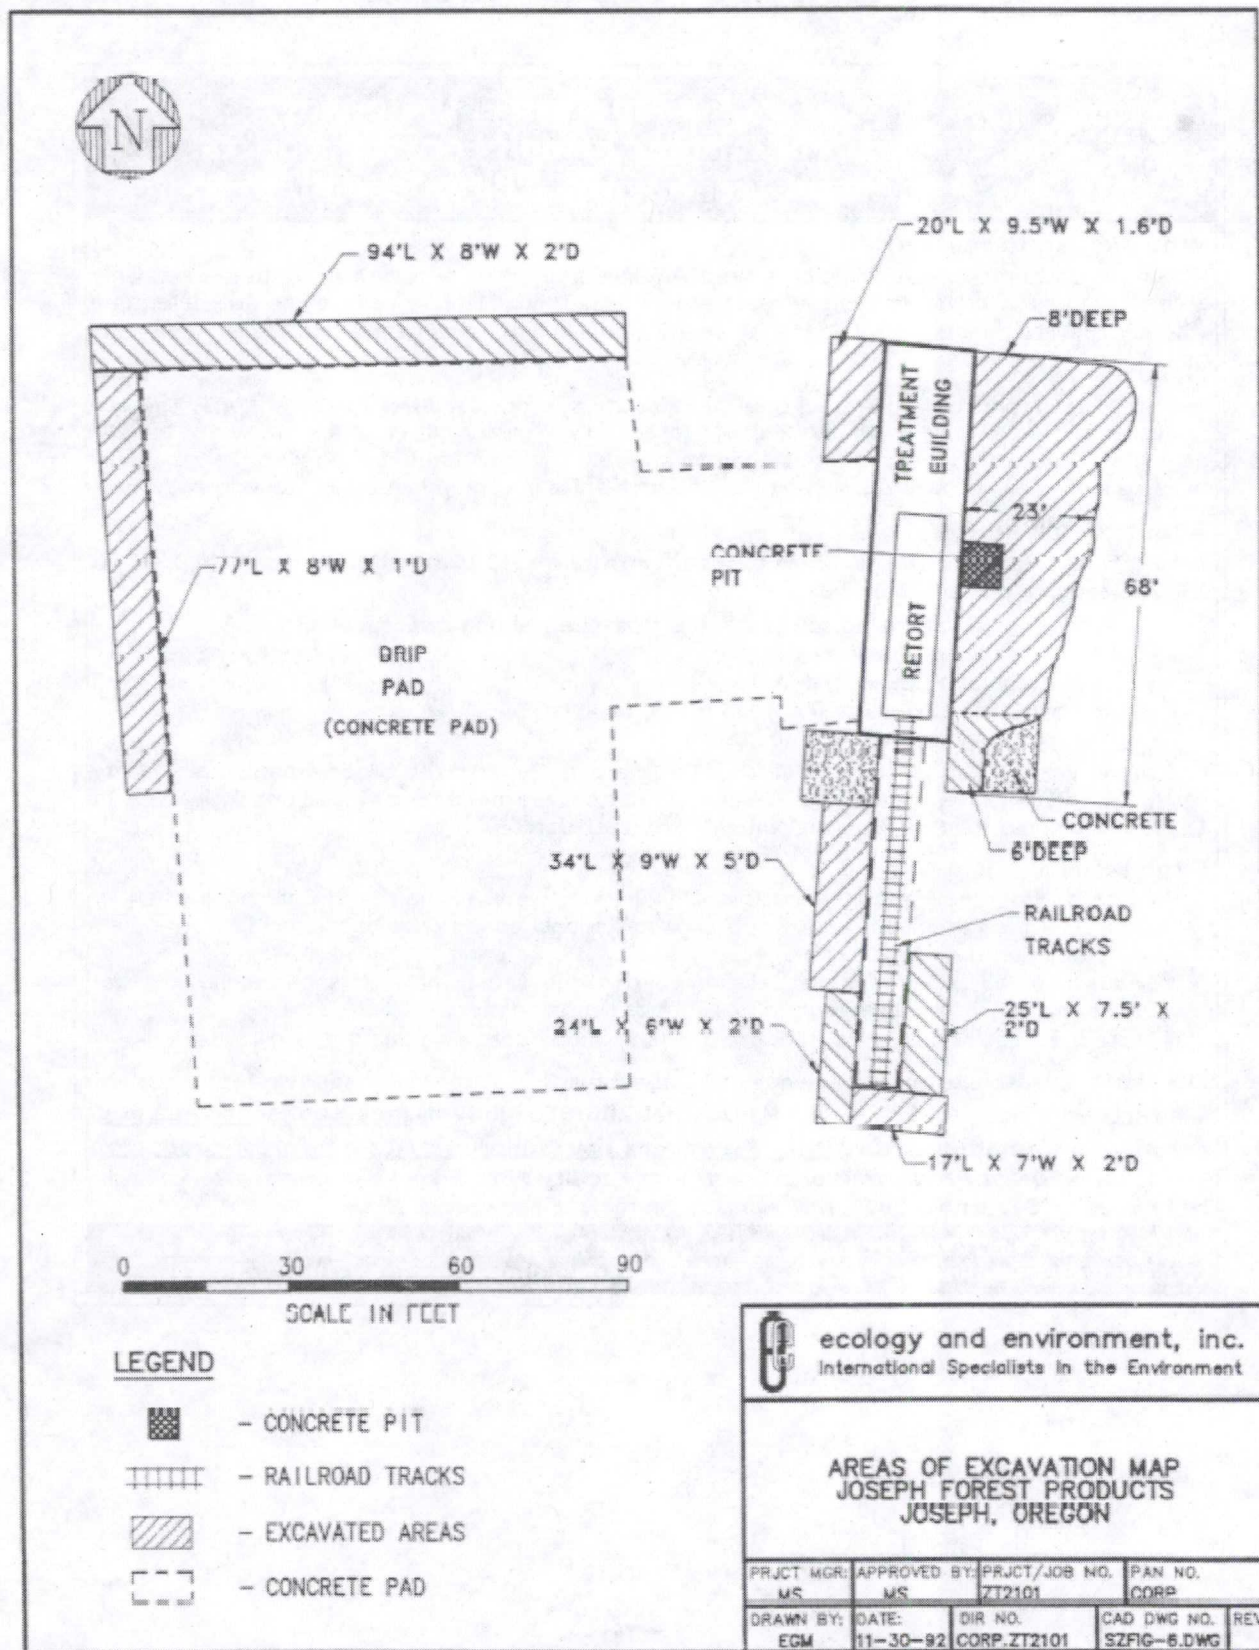
Figure 4 – Drip Pad Excavation Area Map

Only a small area (approximately one acre) contains hazardous substances including the area underneath the drip pad and excavated/backfilled areas adjacent to the drip pad. The remaining area of the site is protective of residential uses.

The concrete drip pad is still present at the site. The excavated areas to the north and west of the drip pad have been backfilled to grade and large rock placed on top as a visual and physical barrier. There are no ongoing cleanup operations or operation and maintenance of facilities at the Site. Any changes to land use will continue to be evaluated during the five-year review process.
